# **Emergency Service Use of UAS**

# By Pat Mika, GIFireE Watch Commander West Midlands Fire Service, United Kingdom

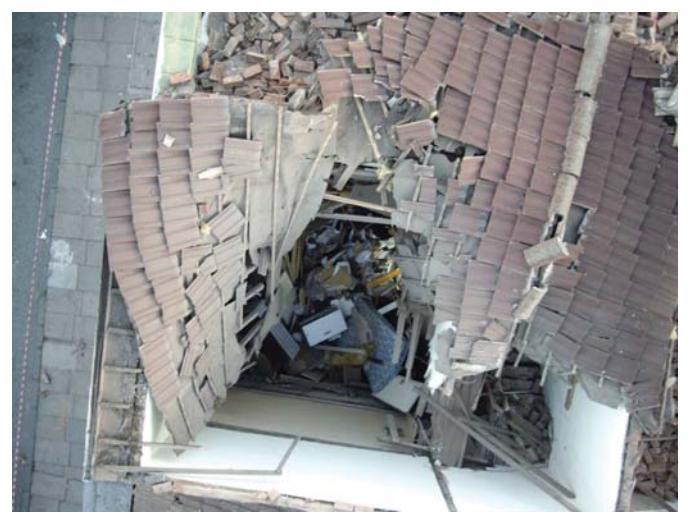
The incident involved a three storey shop and residential premises having had sub standard building alterations which resulted in a complete collapse of the roof and floors one and two. Four persons were rescued but unfortunately one person

The series of 'birds eye view' images which were taken from directly above the structure, clearly showing the condition inside the building after it collapsed proved to be particularly useful. The images were possible to obtain as there is very little downdraft from ISiS. If the drone did cause significant downdraft, it could have disturbed the fragile state of the building and roof, in particular the loose tiles surrounding the opening. The detailed images also provided clear information for the urban search and rescue advisor, which was then used to assist the incident commander when considering tactics and safety.

At an incident involving a collapsed building on West Bromwich High Street in June 2008, the use of ISiS and its 12 megapixel high-quality stills camera provided images that gave full awareness to all agencies attending.

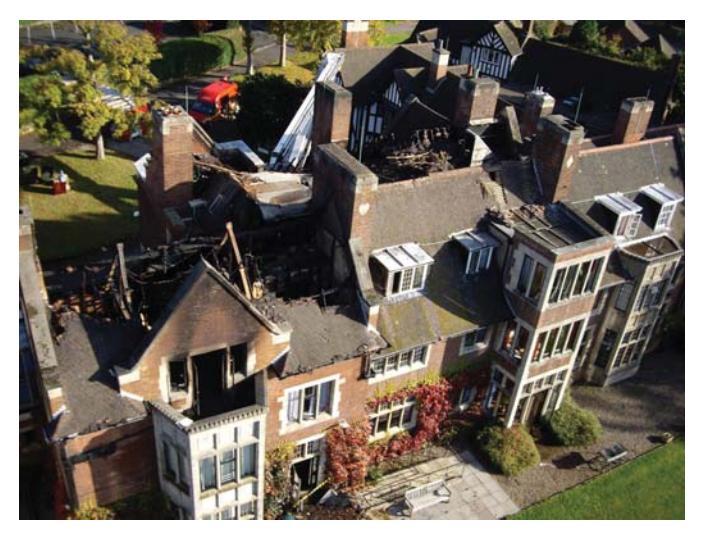
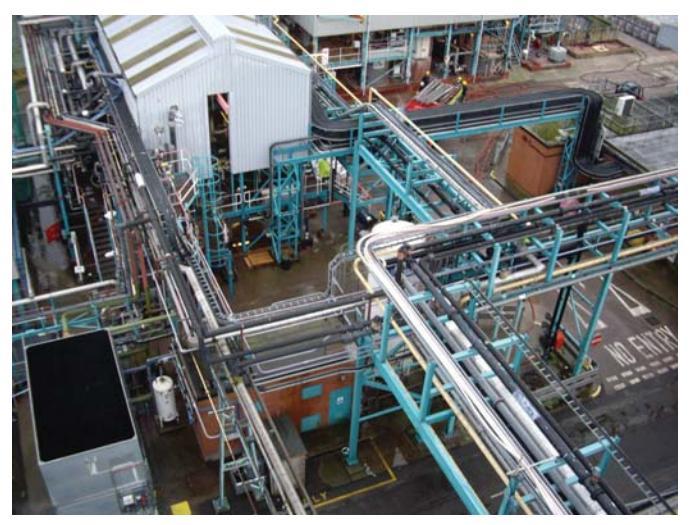
incident command team to view live thermal video showing hot spots across the building's roof. As a direct result of viewing the live moving thermal imagery, the incident command team identified that the roof construction was not quite as they had previously thought, and that there was one particular area of the roof which required attention by firefighters in that it was retaining a substantial amount of heat. The footage enabled the command team to monitor and direct

ISiS was also used during the response to a fire at a residential college in October 2008. Here, the system was used by the
